2019 MBSS Habitat Assessment Certification Training

Howard Community College May 28, 2019

MBSS Habitat Certification

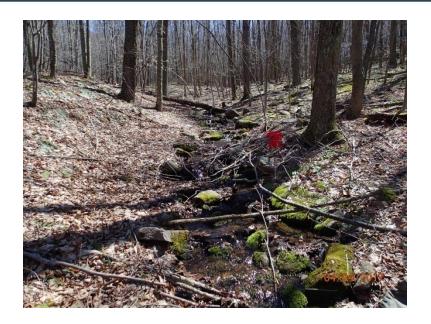
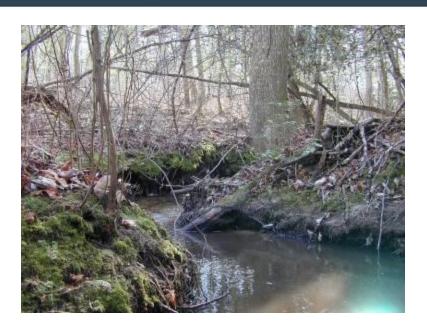
No bank erosion

Extent = 0

Severity = 0 (none)

Average Height = 0

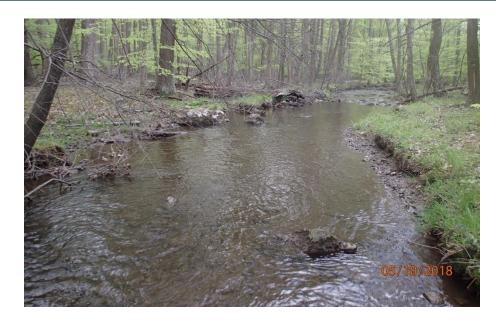
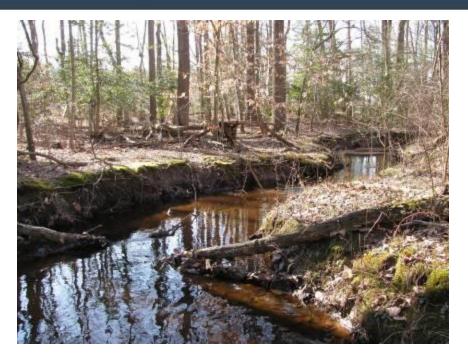
Minimum bank erosion

Extent = 10 m

Severity = 1

Average Height = 0.2 m

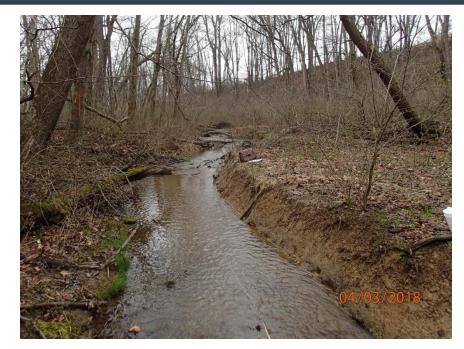
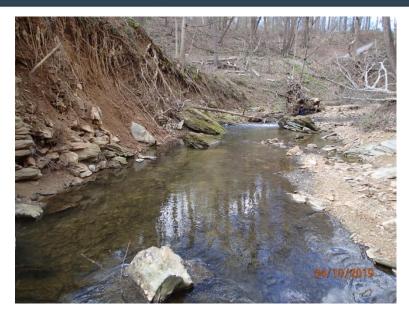
Moderate bank erosion

Extent = 40 m

Severity = 2

Average Height = 0.6 m

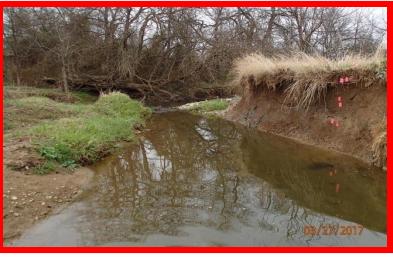
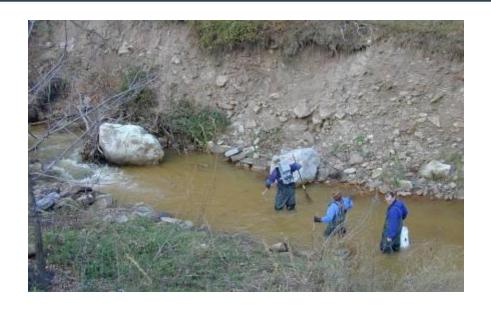
Severe bank erosion

Extent = 75 m

Severity = 3

Average Height = 2 m

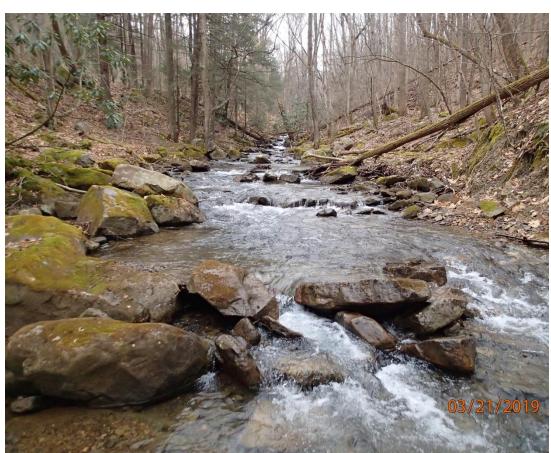
Bar Formation = None

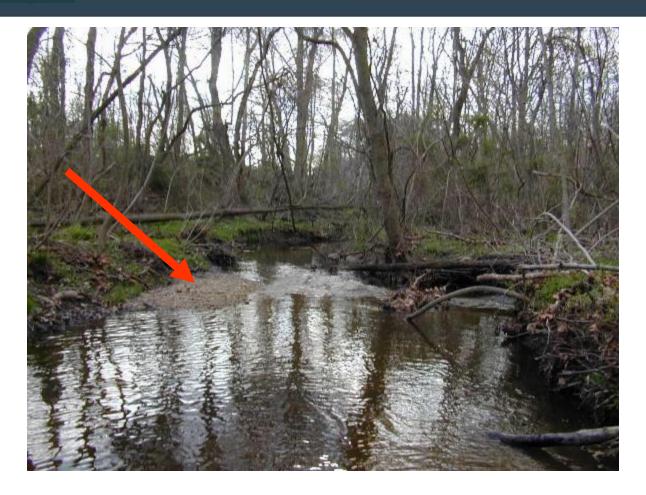
Bar Formation = Minor (Sand, Gravel)

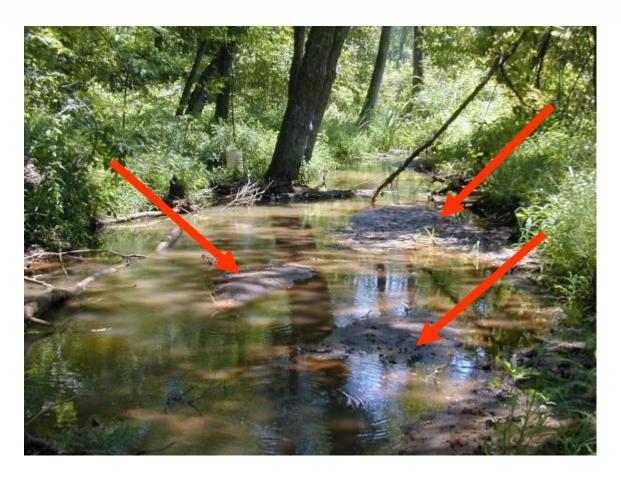
Bar Formation = Moderate (Sand, Silt/Clay)

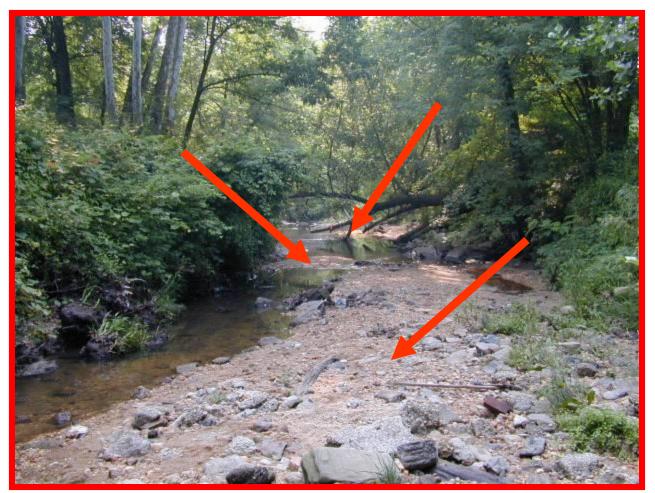
Bar Formation = Extensive (Cobble, Gravel, Sand, Silt/Clay)

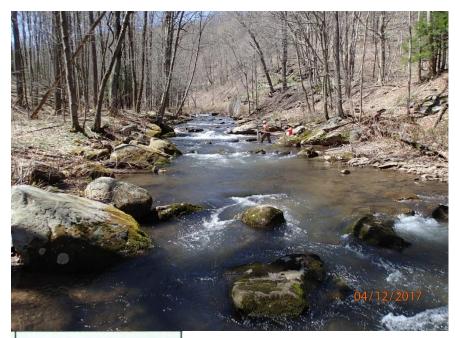
Instream Habitat

Optimal 16-20

Greater than 50% of a variety of cobble, boulder, submerged logs, undercut banks, snags, rootwads, aquatic plants, or other stable habitat

Score = 20

Sub-Optimal 11-15

30-50% of stable habitat. Adequate habitat

Score = 14

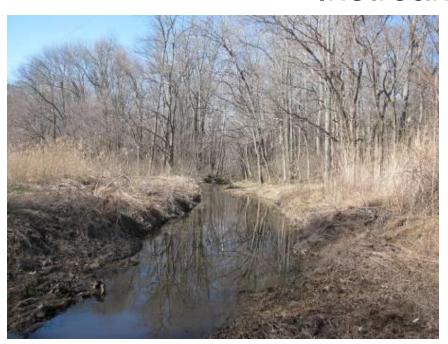
Instream Habitat

Marginal 6-10

10-30% mix of stable habitat. Habitat availability less than desirable Score = 8

Poor 0-5

Less than 10% stable habitat. Lack of habitat is obvious

Score = 4

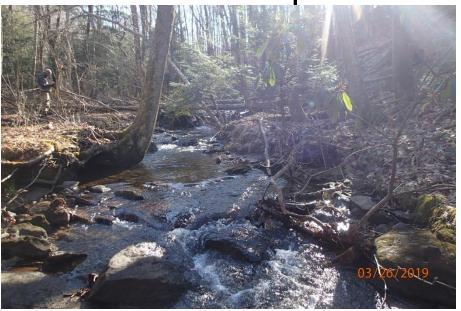
Preferred substrate abundant, stable, and at full colonization potential (riffles well developed and dominated by cobble; and/or woody debris prevalent, not new, and not transient)

Optimal

Score = 19

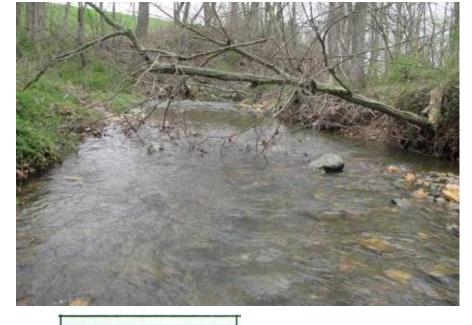
Abund. of cobble with gravel &/or boulders common; or woody de-bris, aquatic veg., undercut banks, or other pro-ductive surfaces common but not prevalent /suited for full colonization

Sub-optimal Score = 14

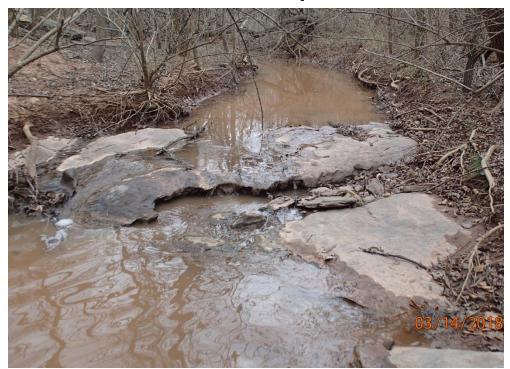
Large boulders and/or bedrock prevalent; cobble, woody debris, or other preferred surfaces uncommon

Marginal Score = 8

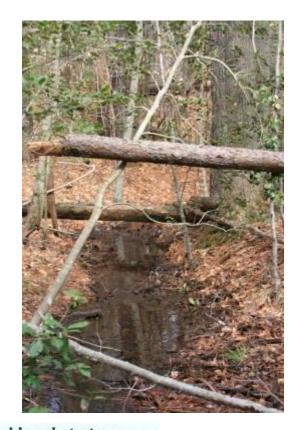
Stable substrate lacking; or particles are over 75% surrounded by fine sediment or flocculent material

Poor Score = 2

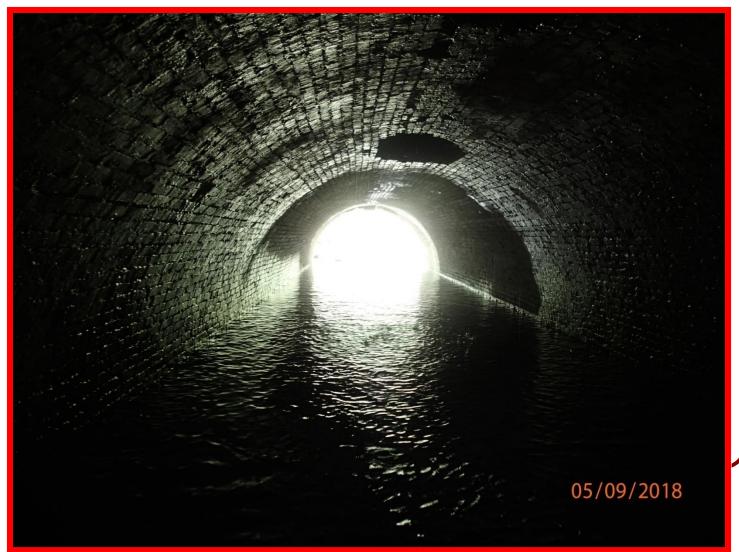
7. Shading^(g)
Percentage of segment that is shaded (duration is considered in scoring). 0% = fully exposed to sunlight all day in summer; 100% = fully and densely shaded all day in summer

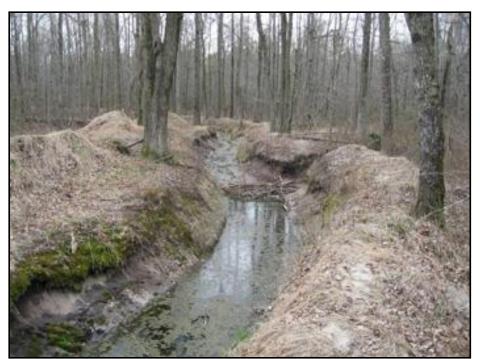
Dredge Spoils

- Survey site for evidence of channel dredging or straightening and
- Indicate presence (Y) or absence (N).
- Indicate the type and linear extent in meters for each bank and for the stream bottom.
